## “On the road again” in Onalaska

Washington State Department of Transportation (WSDOT) is responsible for maintaining state highway Route 508 that runs between the small towns of Morton and Onalaska in Washington. The road winds through an area known as Bear Canyon and provides critical access for local residents and businesses. When a large portion of the hillside gave way due to heavy rains, this major thruway became impassible and WSDOT turned to Skyline’s material capabilities to get local residents on the road again.

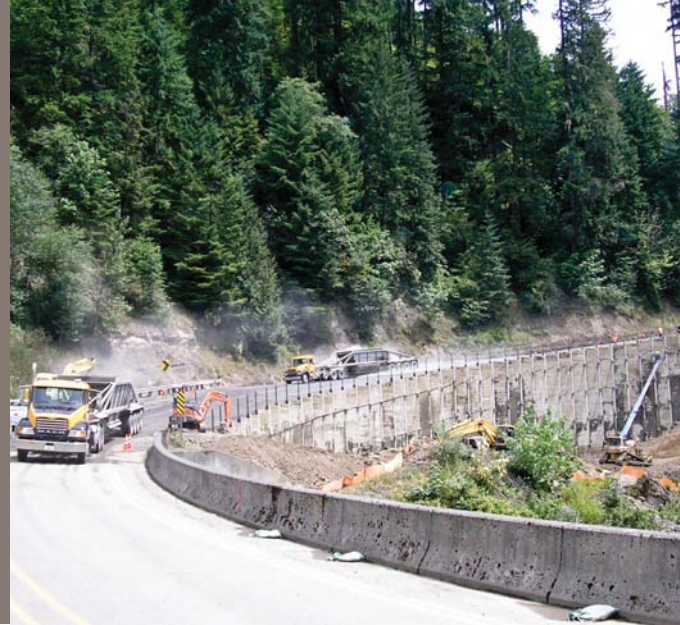
*Pictured on right: Final phase of repairs after ground stabilization wall is in place.*

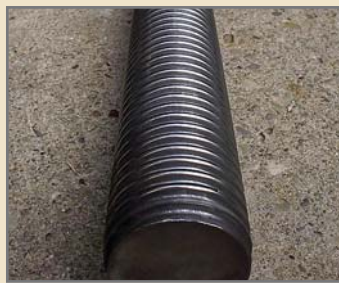
Threaded bar for ground anchors

This soldier pile wall was not typical: permanent ground anchors were designed into the beam configuration to stabilize the earth underneath the roadway. Skyline was able to reduce the construction schedule and field labor by providing the pipe pocket anchors pre-fabricated into the beams. Our fabrication facility is a stone’s throw from the beam mill. Our convenient location proved to further reduce transportation and handling costs. Lastly, the steel was treated with a weathered coating prior to delivery, extending the service life of the structure.

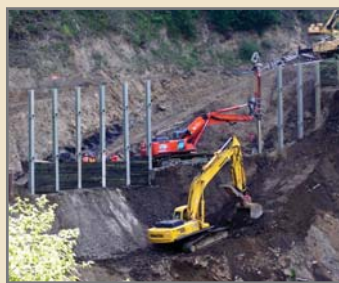
Construction of soldier pile wall

Soldier beam and lagging walls are very common earth retention structures. They are a standard construction method with relatively low material and installation costs. The original beam design called for 12 x 65 wide flange beams, but availability did not fit this emergency repair response. Skyline

Steel was able to offer a comparable 12 x 74 H-pile section.

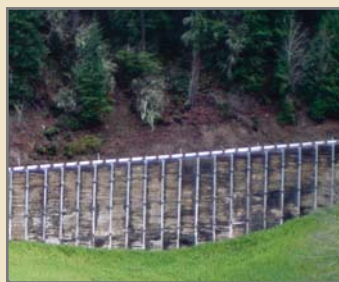
Completed ground stabilization wall
