French in origin, a fitting Canadian Solution

► Problem

The Ministry of Transport of Quebec needed to construct a new bridge in Gatineau, Quebec. The new bridge is located over environmentally sensitive wet lands and as such the general contractor was denied access onto the wet lands. The use of earth dyke for construction access was not feasible. Given these restrictions, the apparent option for access to construct the bridge piers was a temporary trestle.

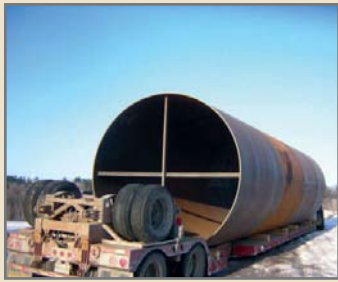
Steel casing being delivered to site.

The caissons were designed with a permanent steel casing 3600mm diameter x 25mm wall

thickness (12ft x 1in), produced out of the Skyline Steel rolled & welded facility in Newton, Illinois and supplied by Skyline Canada Ltd. The steel casing lengths were custom fabricated at our facility to accommodate the anticipated bedrock profile. The casings varied from 12m (40ft) to 20m (66ft) in length and weighing up to 45 tons. This material service was just another example of how Skyline partners with customers to provide the most value.

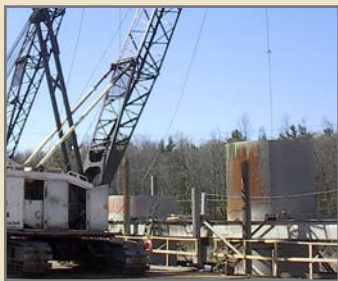
Caissons placed in rigid template frame.

Caissons were installed through the overburden and seated into the bedrock, with 9m rock sockets. The bedrock sloped 30 degrees along the transverse alignment of the pier footprint, making the caisson installation very challenging to achieve the stringent verticality tolerance of 1%. The caissons were then cleaned out and the bedrock sockets inspected. The inspection included a sub-
